Manhole Inspection Summary

Manhole # S51MM_001MH

Insp Date: **3/19/08 9:01 AM**

Location Address: **Ellwood**

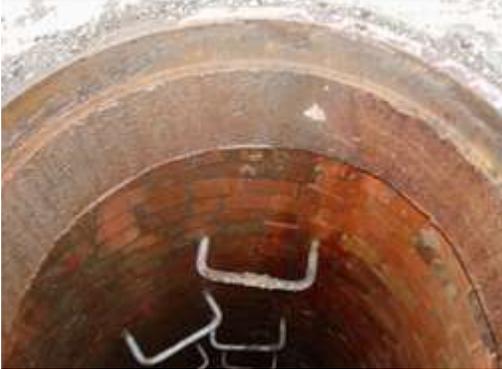
Defect 1

Adjustment Joint

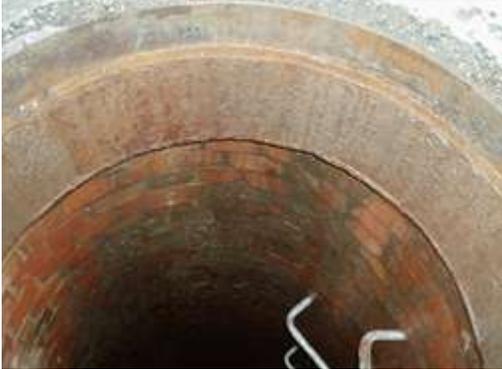
Defect 2

Frame Leaks

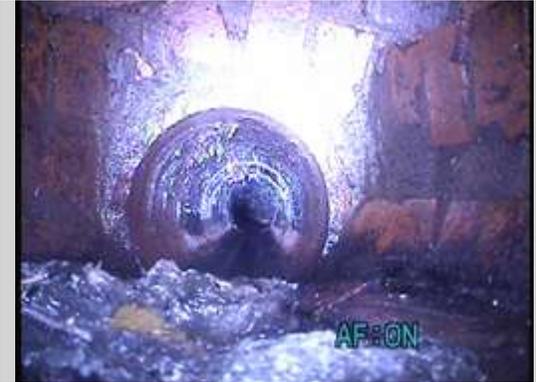
12 O'Clock Outflow

8 in. Circular Gravity Sewer
Pipe Out @ 12 O'Clock

Pipe Height: **8.4** (in.) Rod and Bar (Angled)
Pipe Material: **Clay** Pipe Lined
Invert Depth: **12.70** (ft.) Flow Characteristics: **Fast**
Deposits: None **Mud** Sludge **Debris** Grease
Silt Depth: **1** (in.) Deposits Extent: **Light**
Infiltration: **None** Pipe Seal Cond: **Sound**

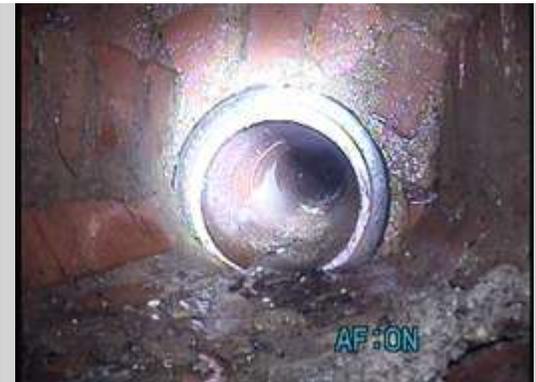
5 O'Clock Inflow

8 in. Circular Gravity Sewer
Pipe In @ 5 O'Clock

Pipe Height: **8.4** (in.) Rod and Bar (Angled)
Pipe Material: **Clay** Pipe Lined
Invert Depth: **12.40** (ft.) Flow Characteristics: **None**
Deposits: None **Mud** Sludge **Debris** Grease
Silt Depth: **2** (in.) Deposits Extent: **Light**
Infiltration: **Evidence** Pipe Seal Cond: **Sound**

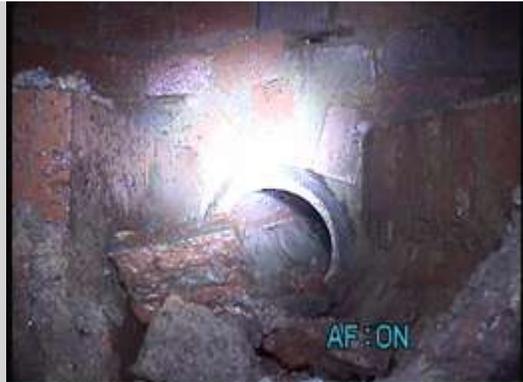
7 O'Clock Inflow

Pipe Height: **8.4** (in.) Rod and Bar (Angled)
Pipe Material: **Clay** Pipe Lined
Invert Depth: **12.40** (ft.) Flow Characteristics: **None**
Deposits: None **Mud** Sludge **Debris** Grease
Silt Depth: **3** (in.) Deposits Extent: **Medium**
Infiltration: **None** Pipe Seal Cond: **Sound**

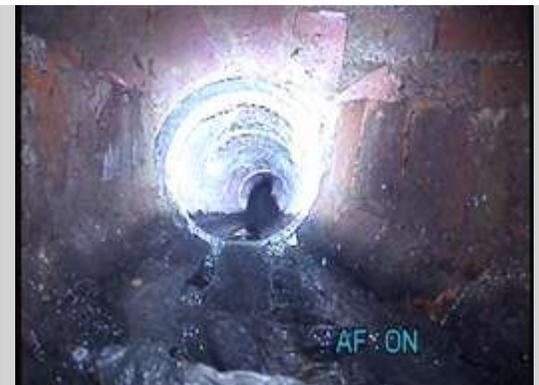
9 O'Clock Inflow

Pipe Height: **8.4** (in.) Rod and Bar (Angled)
Pipe Material: **Clay** Pipe Lined
Invert Depth: **12.20** (ft.) Flow Characteristics: **Fast**
Deposits: None Mud Sludge **Debris** Grease
Silt Depth: **1** (in.) Deposits Extent: **Light**
Infiltration: **None** Pipe Seal Cond: **Sound**
